Mechanical Testing

REPORT NO: MT-15/203

TESTING OF A "SAFETY BASE" TEMPORARY RAILING SYSTEM

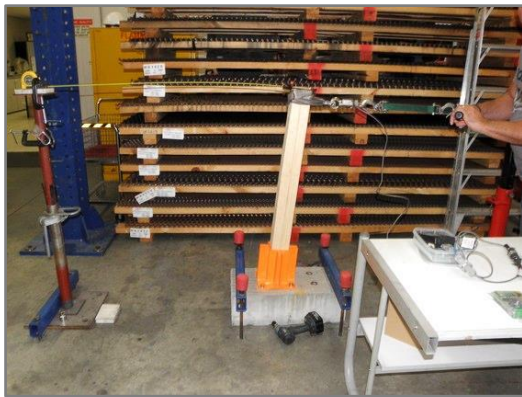
FIG. A1
POST IN CONCRETE INSTALLATION
OUTWARD 1200N LOAD TEST

- Static Inward Test to 735N (350N x 2.1m rails)
Max deflection $\delta = 58\text{mm} < \delta_{\text{max}} 101\text{mm}$ **PASS**
- Static Outward Test to 735N (350N x 2.1m rails)
Max deflection $\delta = 63\text{mm} < \delta_{\text{max}} 101\text{mm}$ **PASS**
- Static Outward Test to 1200N
Distortion of the bottom flange and washes observed.
No sign of structural failure observed **PASS**

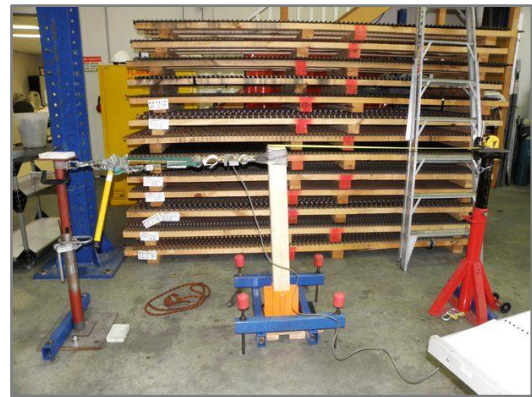
FIG. A2
POST IN PLYWOOD WITH
BACKING TIMBER INSTALLATION
INWARD 600N LOAD TEST

- Static Inward Test to 735N (350N x 2.1m rails)
Max deflection $\delta = 57\text{mm} < \delta_{\text{max}} 101\text{mm}$ **PASS**
- Static Outward Test to 735N (350N x 2.1m rails)
Max deflection $\delta = 62\text{mm} < \delta_{\text{max}} 101\text{mm}$ **PASS**
- Static Outward Test to 1200N
Distortion of the bottom flange and washes observed.
No sign of structural failure observed **PASS**

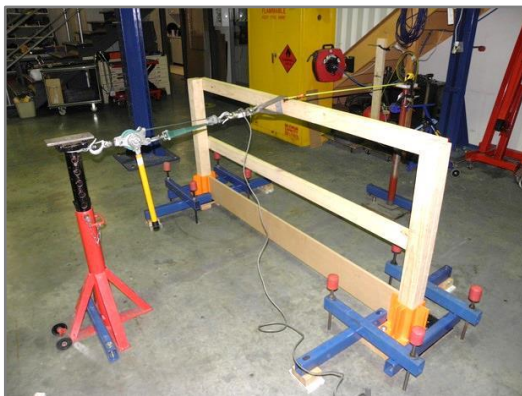
FIG. A5
TOP RAIL
OUTWARD LOAD TEST

Static Outward Test to 600N

Max deflection $\delta = 15\text{mm} < \delta_{\text{max}} 101\text{mm}$ **PASS**
